# Intel<sup>®</sup> 82574 Family Gigabit Ethernet Controller Specification Update

*July 2015  
Revision 4.0*

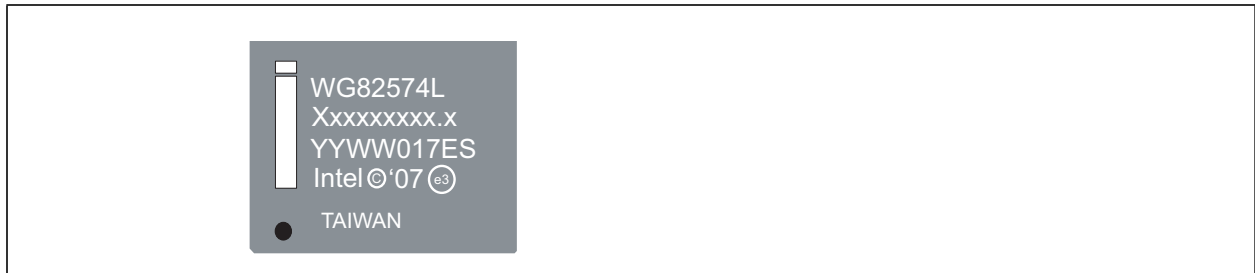
Figure 1. Engineering Samples Top Marking Example With Identifying Marks

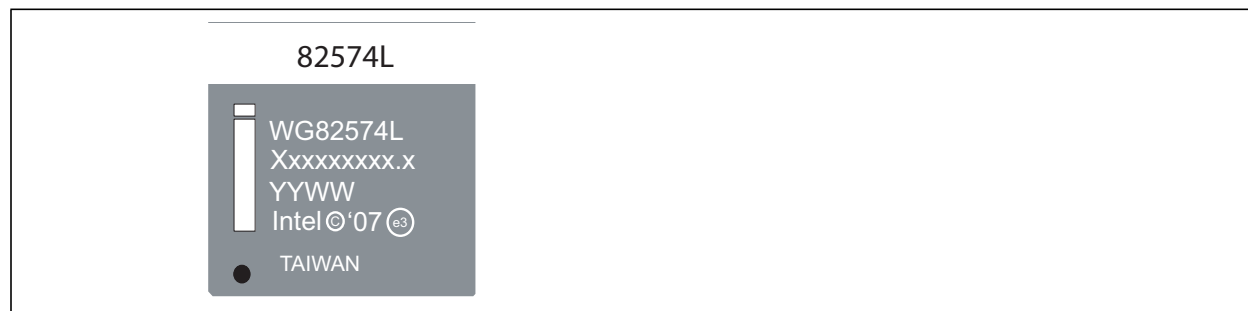
**Figure 2. Production Top Marking Example With Identifying Marks**

1. See [Figure 2](#).
