Intel® 82574 Family Gigabit Ethernet Controller Specification Update

*July 2015
Revision 4.0*

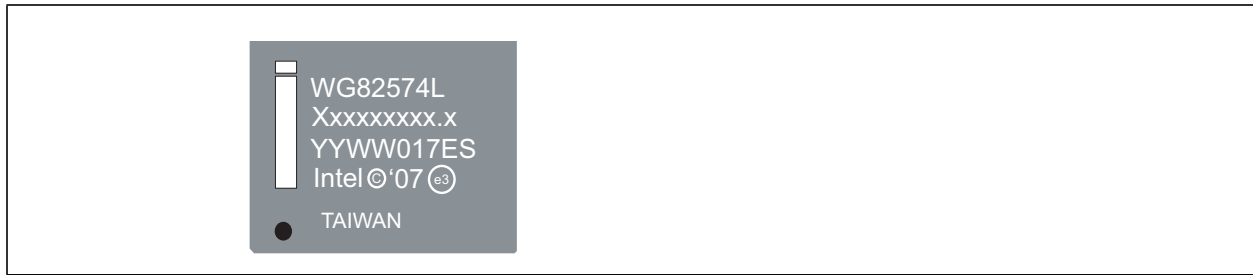
Figure 1. Engineering Samples Top Marking Example With Identifying Marks

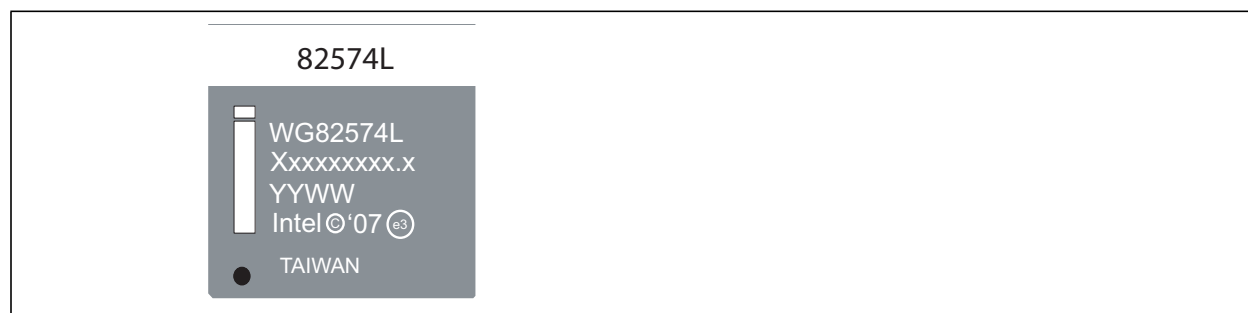
Figure 2. Production Top Marking Example With Identifying Marks

1. See [Figure 2](#).
