8th and 9th Generation Intel[®] Core[™] Processor Family

Specification Update

***Supporting 8th Generation Intel[®] Core[™] Processor Families for
S/H/U Platforms, formerly known as Coffee Lake***

***Supporting 9th Generation Intel[®] Core[™] Processor Families
Processors for S/H Platforms, formerly known as Coffee Lake
Refresh***

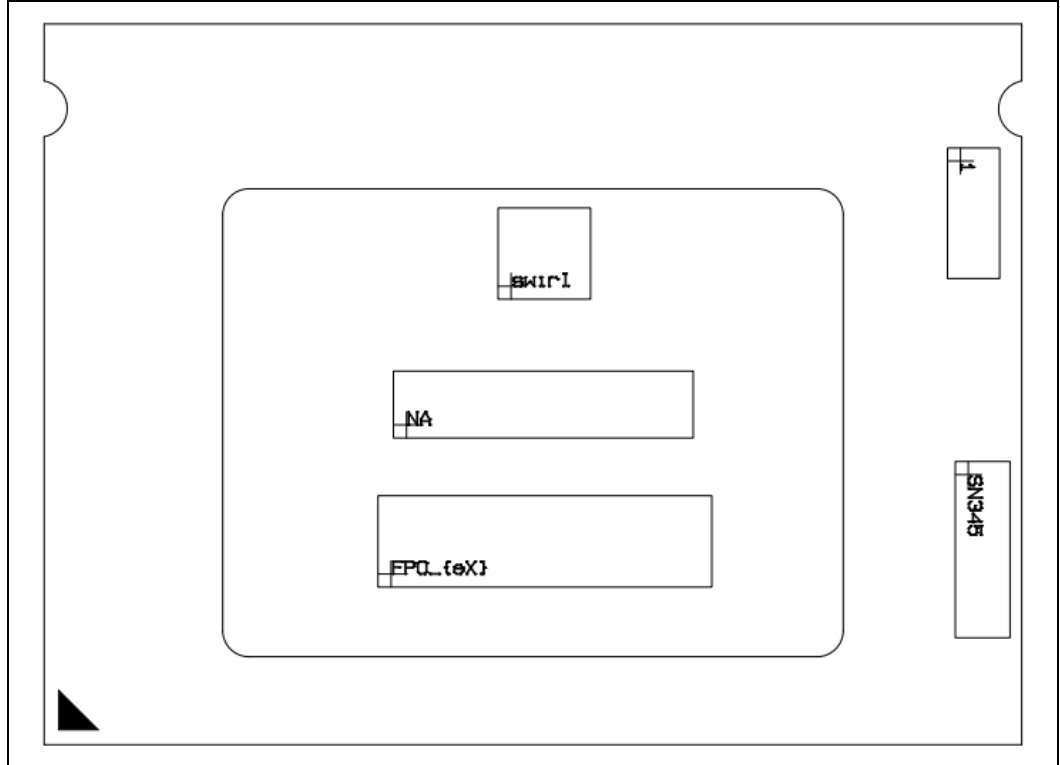
Pin Count: 1151
Package Size: 37.5 mm x 37.5 mm

| Figure 2-1. Processor Based on S - Processor Line LGA Top-Side Markings | 8 |

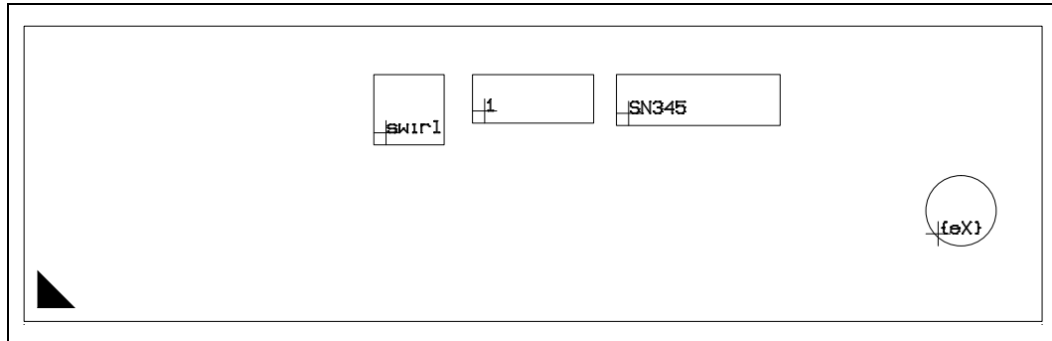
Pin Count: 1440
Package Size: 42 mm x 28 mm

Note: "1" is used to extract the unit visual ID (2D ID).

| Figure 2-2. H-Processor Line Package BGA Top-Side Markings | 9 |

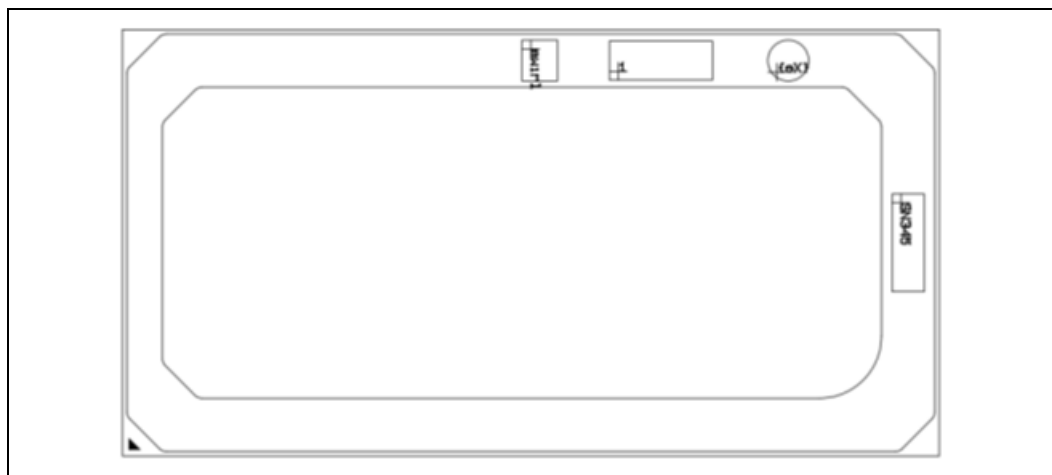
Pin Count: 1528
Package Size: 46 mm x 24 mm

| Figure 2-3. U-Processor Line Multi-Chip Package BGA Top-Side Markings | 9 |
